OFIC (GB) Limited.
16 Hanover Square,
LONDON. W1R 9AJ.

REPORT NO. D70817/1

WIND SUCTION TESTS ON ONDULINE PANELS

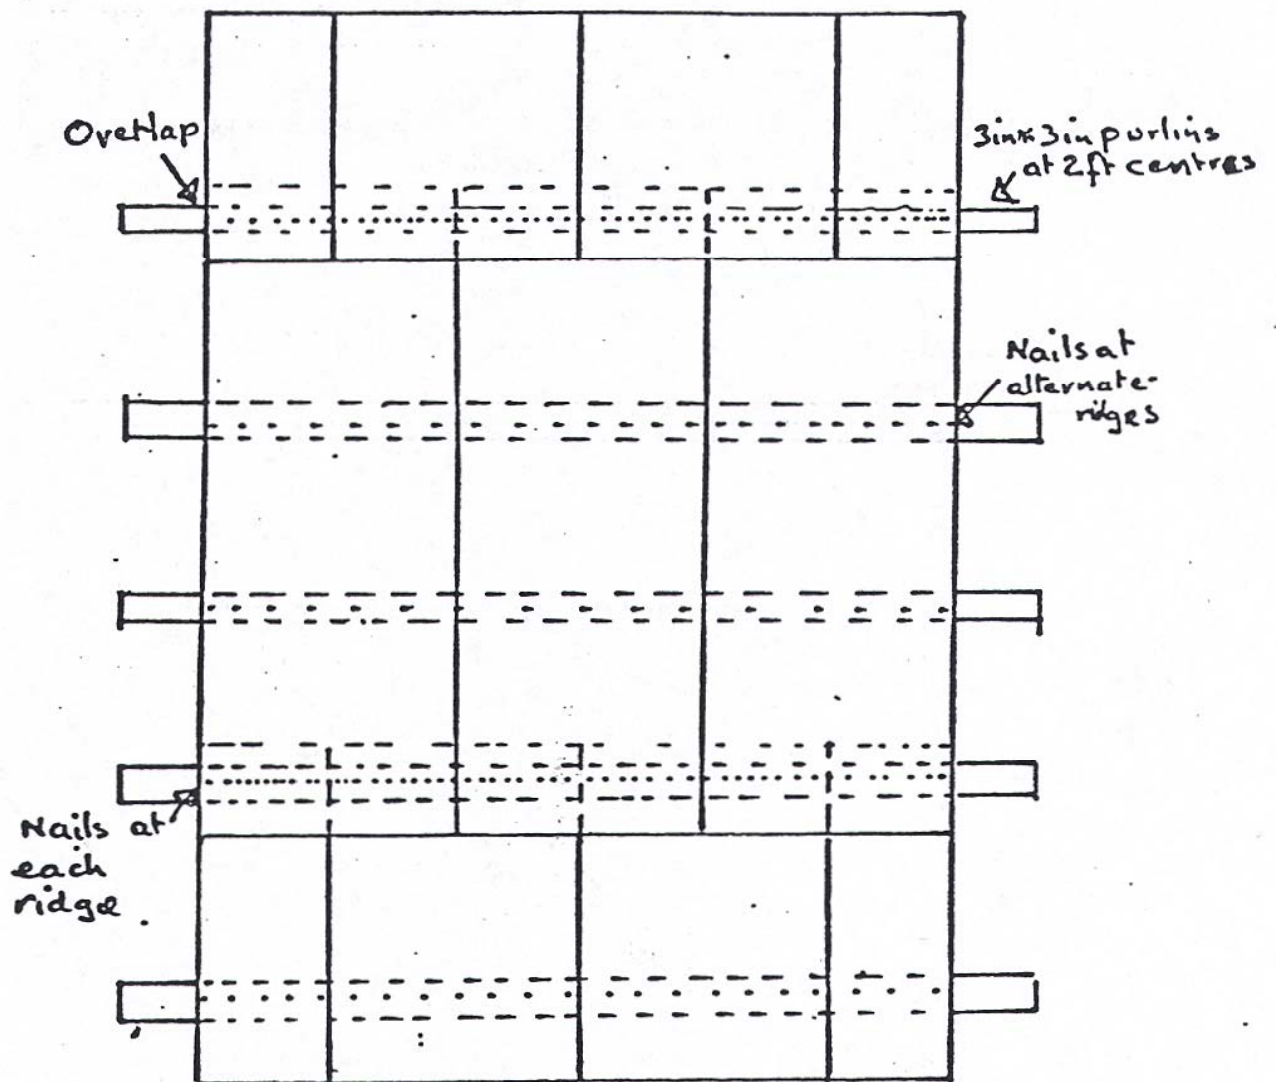
Six sheets were selected at random for test. Three were used whole, but two more were cut in half transversely and the further two were cut into quarters. Two half sheets and two quarter sheets were first laid at one end with approximately 1 foot overlapping the end of the frame and then the three full sheets were laid so that the longitudinal joints in the whole sheets were midway between those in the half sheets. The rig was completed by two half sheets and two quarter sheets at the further end. The overlap was of course approximately 7 inches, as dictated by the spacing of the purlins.

Under a uniformly distributed load of 32.5 lb/ft^2 , there was no sign of distress, undue deformation or failure of the roof. Under a load of 37 lb/ft^2 , deformation of the corrugations occurred followed by pull-through of the nails on the intermediate purlins, ie. where the sheets were nailed at alternate ridges.

Arrangement of roof sheets for Load Testing
